FIGURE 20
Spent Acid Storage Tank
(Monel Tank)
SWMU #005

FACILITY: INCO ALLOYS INTERNATIONAL, INC.

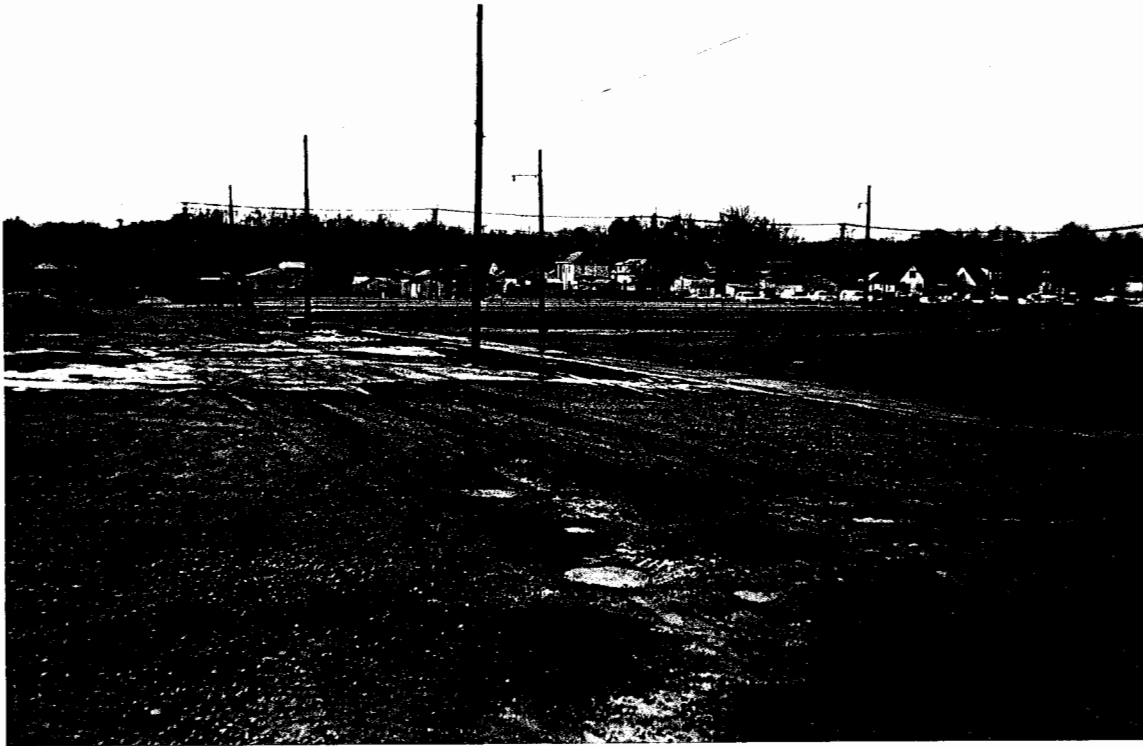
PHOTO No.: 5 of Roll 4

DESCRIPTION: Looking from tank toward ditch in sulfuric acid spill area.
Spill traveled through this area, shown in the above picture,
and was discharged to POTW.

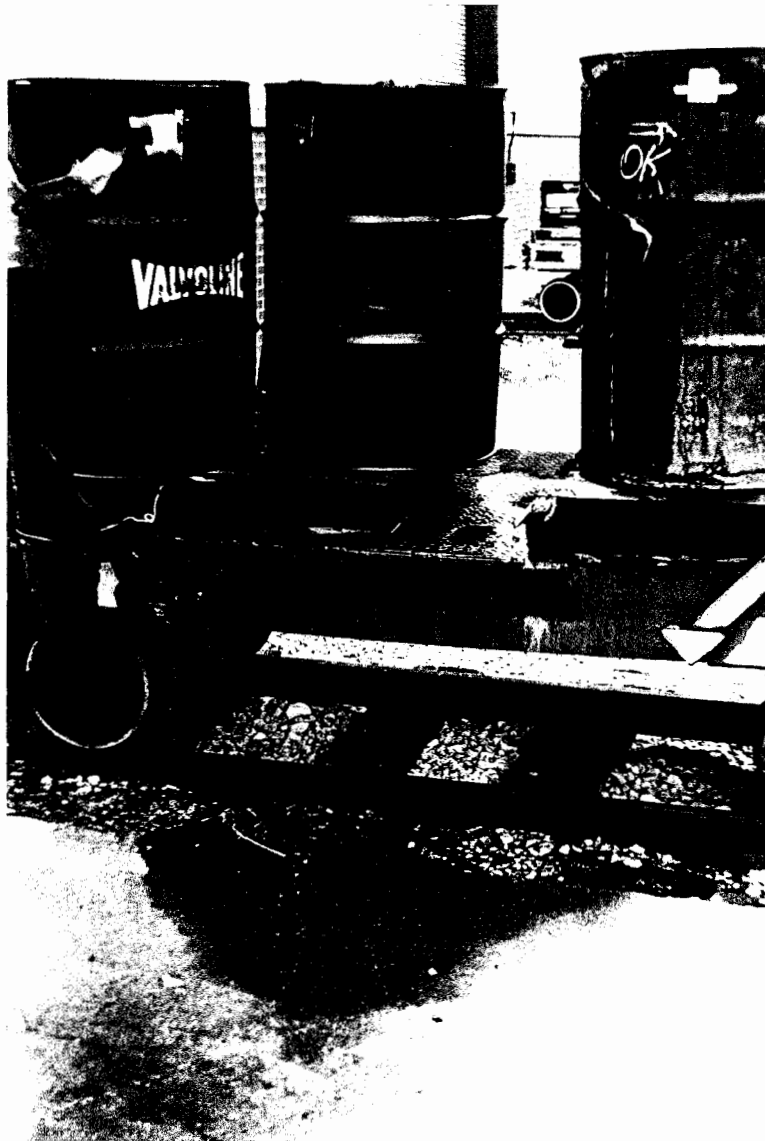
PHOTO No.: 7 of Roll 4

DESCRIPTION: Leaking storage drum (hydraulic oil). It should not have been sent to container storage area. This is in the general area of drum storage area, SWMU 001.

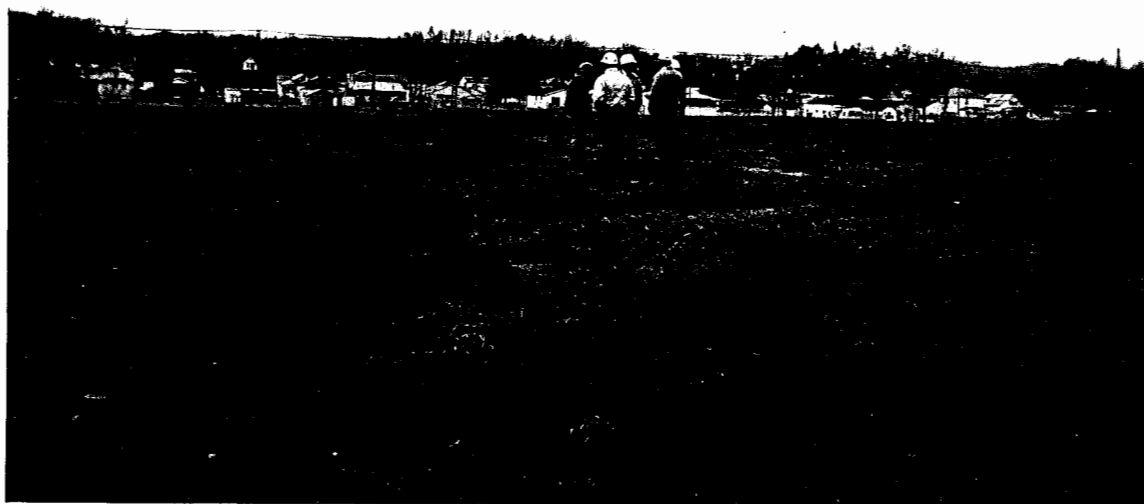
PHOTO No.: 8 of Roll 4

DESCRIPTION: Closed waste pile area. Tailings, slag and carbonates were stored in closed Lagoon No. 3.

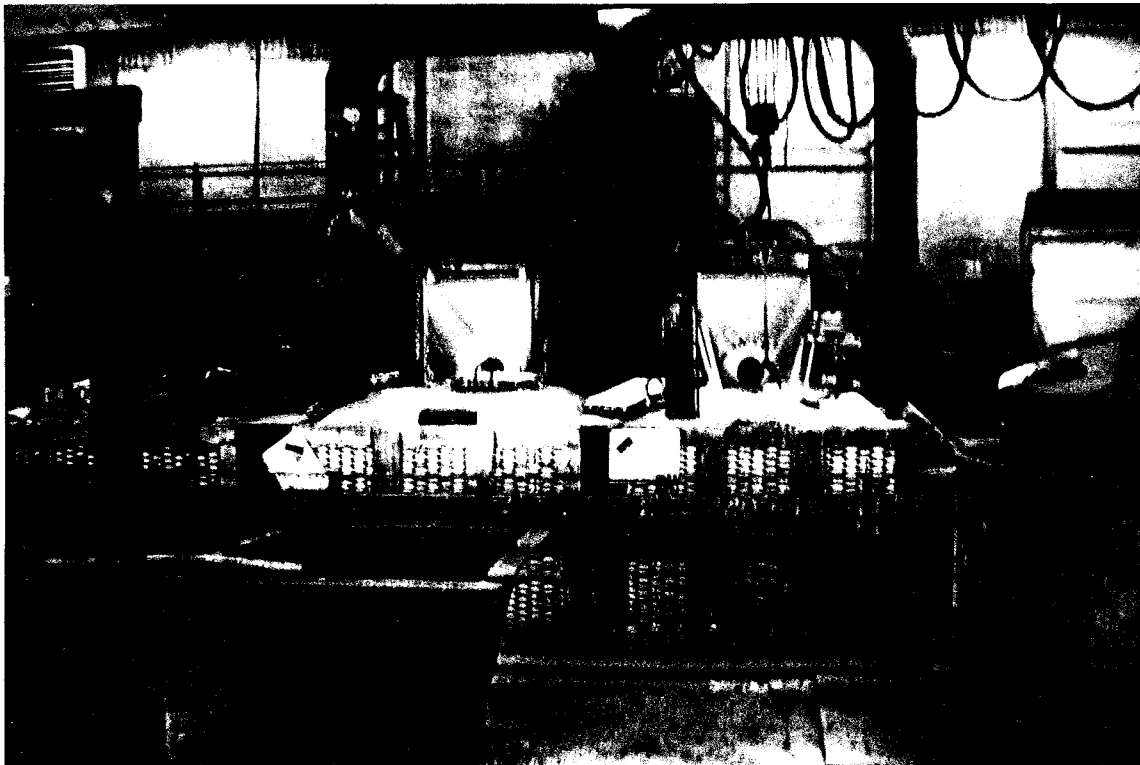
PHOTO No.: 10 of Roll 4

DESCRIPTION: Closed barium chloride salt area - no longer using ball.

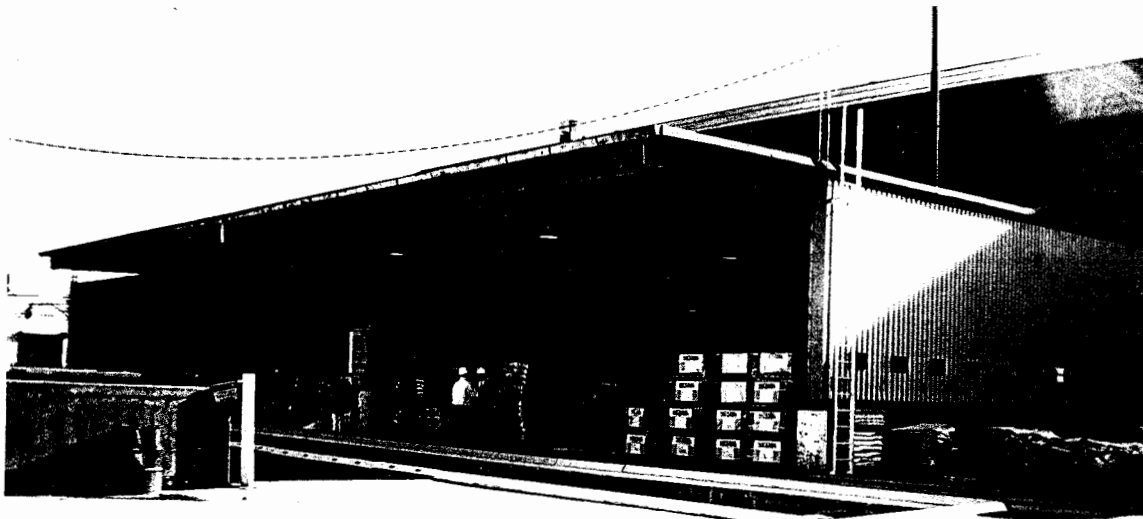
PHOTO No.: 11 of Roll 4

DESCRIPTION: Closed baghouse dust storage area. Was previously permitting but closed on March 17, 1983. Water drains to city sewers.

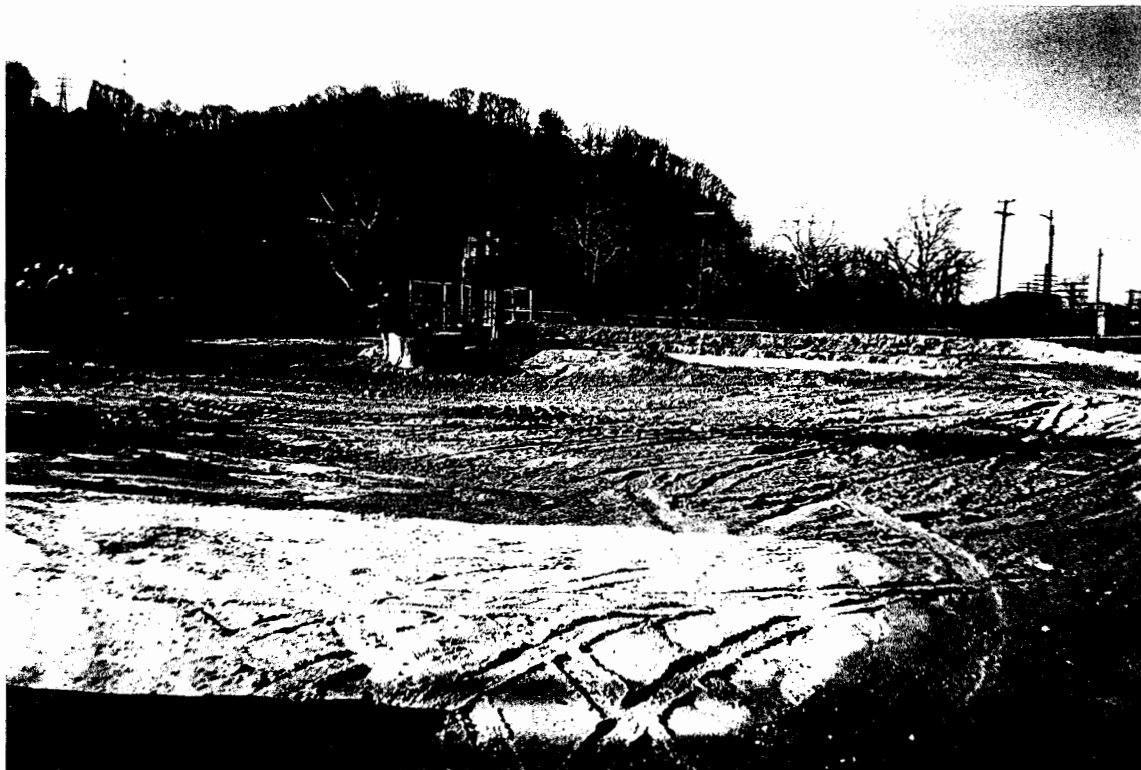
PHOTO No.: 2 of Roll 3

DESCRIPTION: Existing tailing pond area, pond is in operation. Pot lining materials are stored in the pond presently. This unit is permitted by WV, Office of Water Resources, NPDES Section.

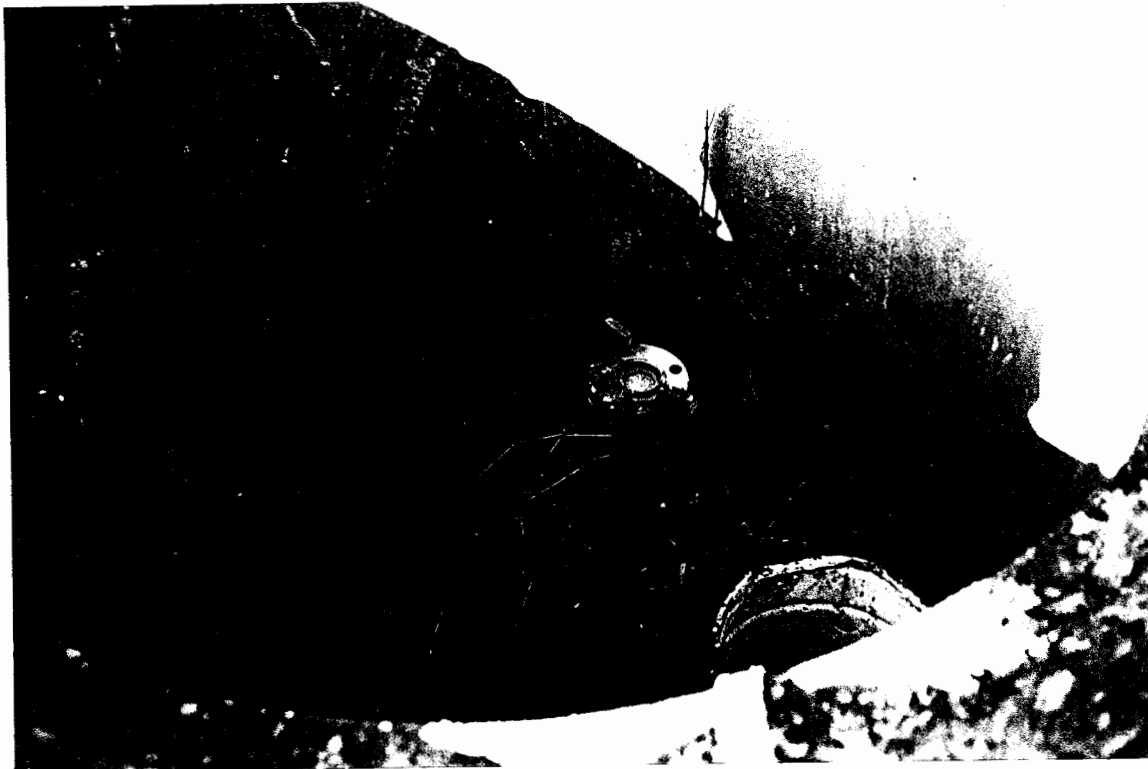
PHOTO No.: 3 of Roll 3

DESCRIPTION: Monitoring Well Head - upstream in existing west tailing pond in operation Well is surrounded with a concrete protective barrier

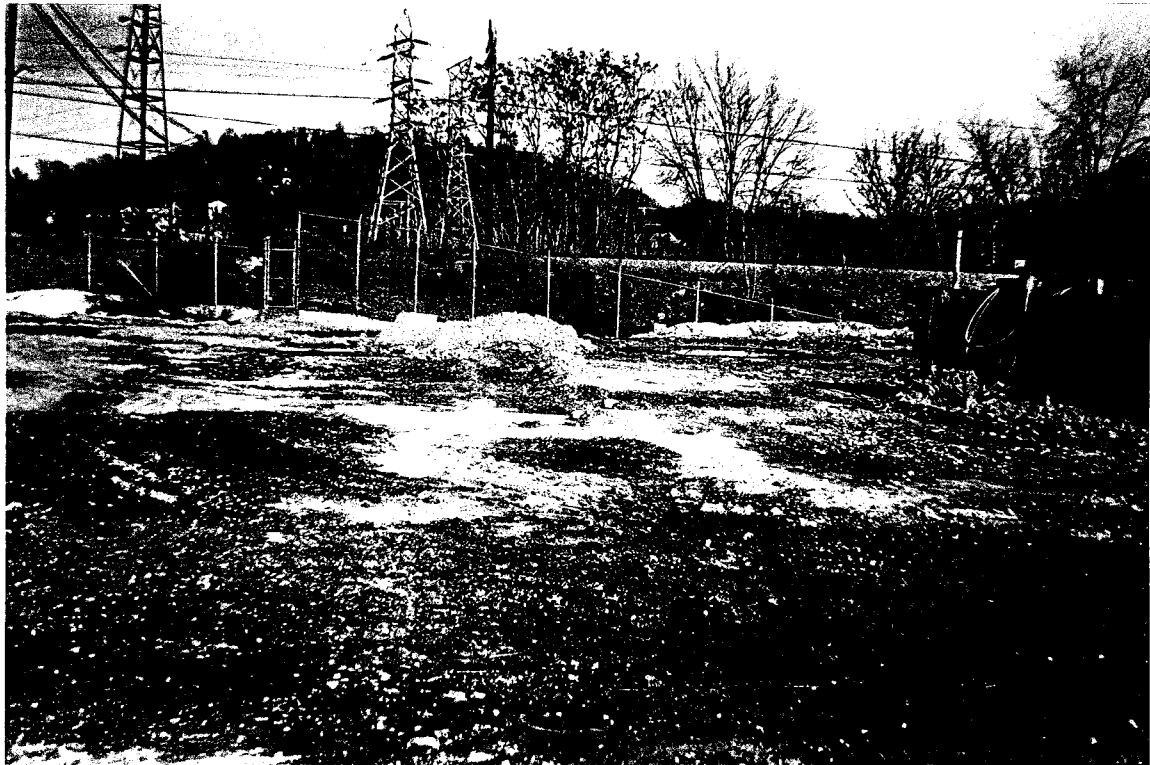
PHOTO No.: 5 of Roll 3

DESCRIPTION: Old location of lagoon #2, closed in 1980.

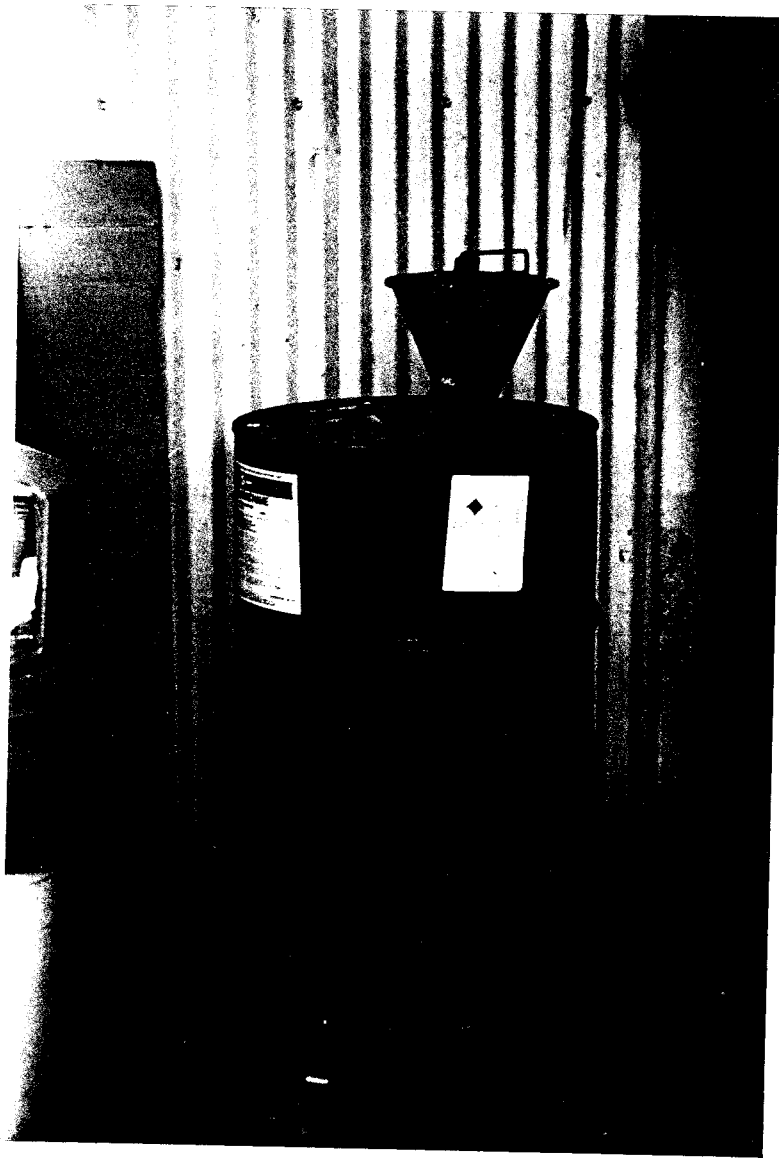
PHOTO No.: 7 of Roll 3

DESCRIPTION: 1,1,1 Tri-chloroethane satellite Accumulation, located in
Primary Mill drilling station.

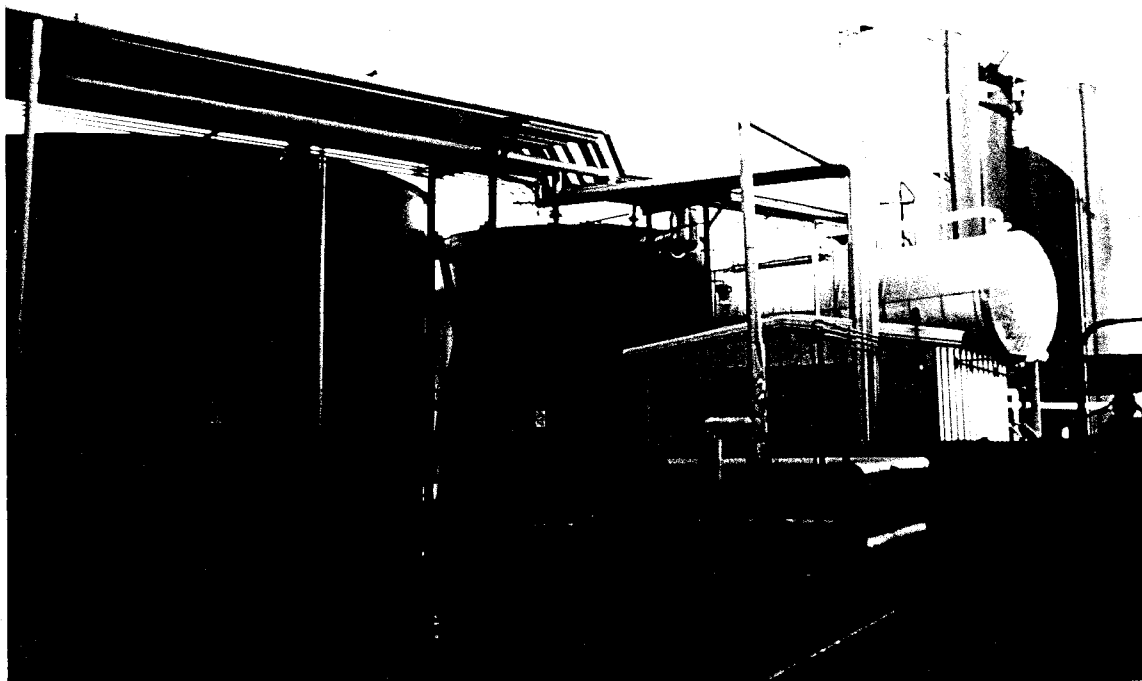
PHOTO No.: 8 of Roll 3

DESCRIPTION: Soluable hydraulic oil recycling and storage tanks.

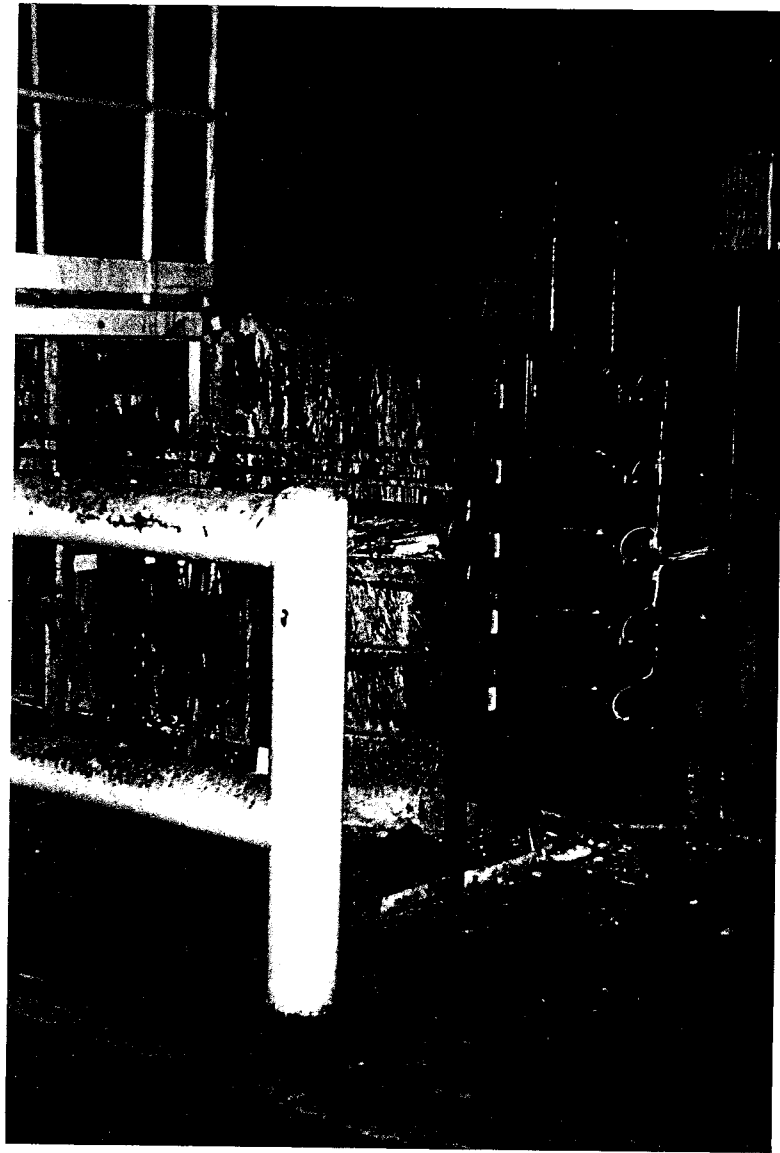
PHOTO No.: 10 of Roll 3

DESCRIPTION: Kolene salt bath, satellite accumulation of hazardous waste.

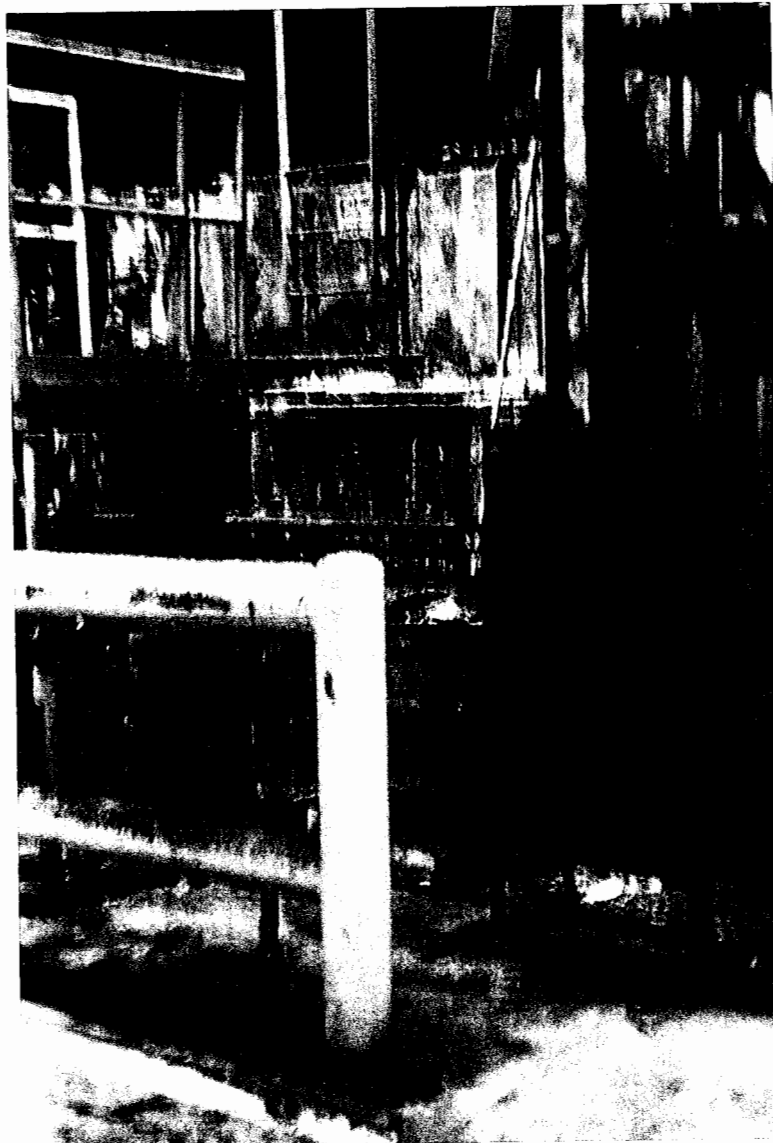
PHOTO No.: 11 of Roll 3

DESCRIPTION: Kolene salt bath, satellite accumulation of hazardous waste.

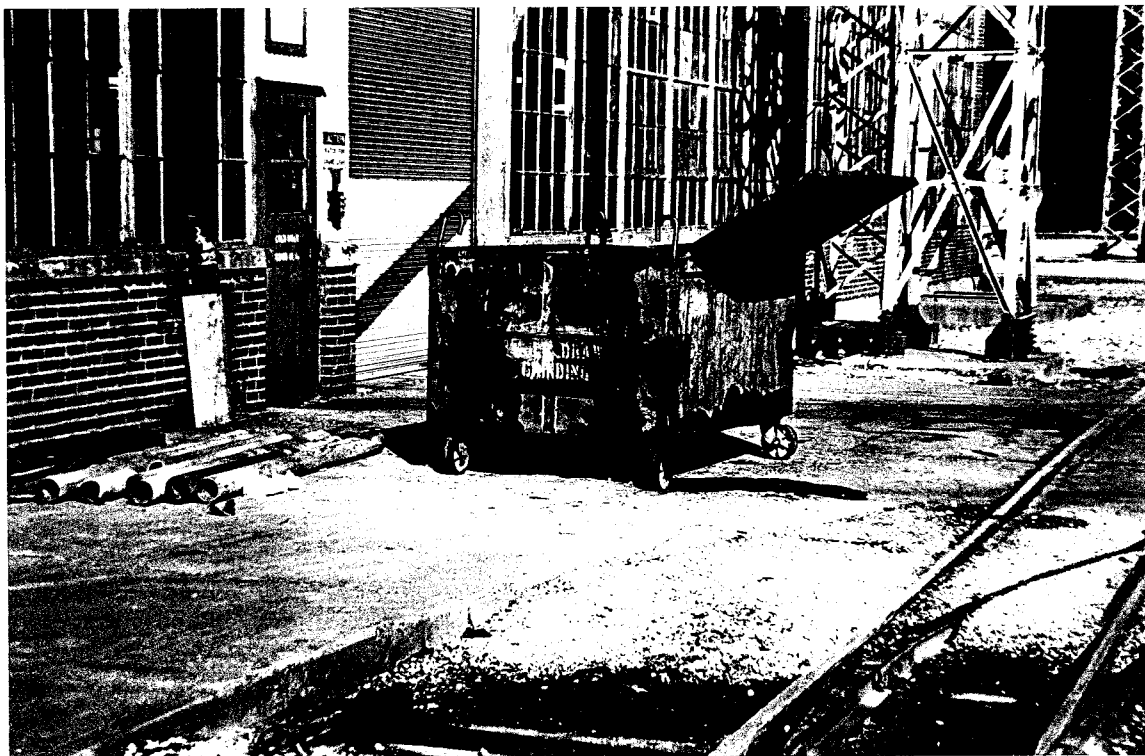
PHOTO No.: 13 of Roll 3

Trash Dumpster containing waste oil

Dumpster with hydraulic waste oil dripping from it, noticed outside cold draw building (west wing).

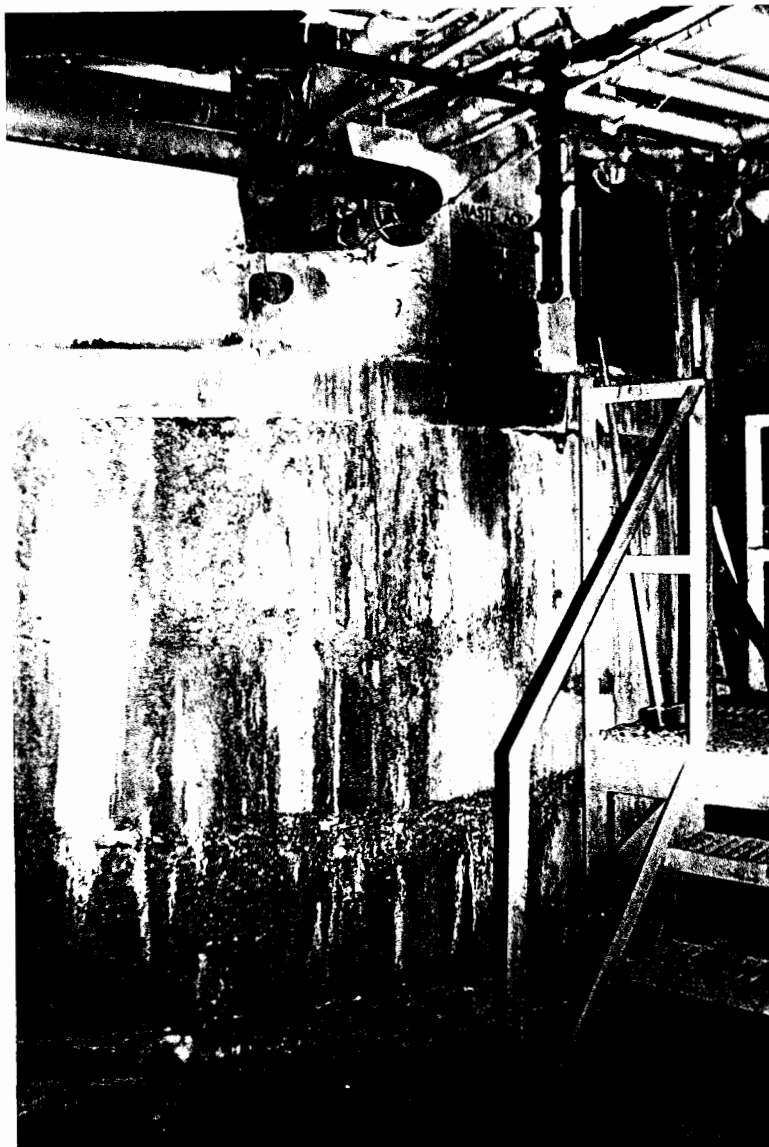
PHOTO No.: 8 of Roll 2

DESCRIPTION: Neutralization (waste acid) tank located in enclosed building
- Note small overflow container at bottom of tank - goes to pretreatment, floor drain goes to final treatment unit.

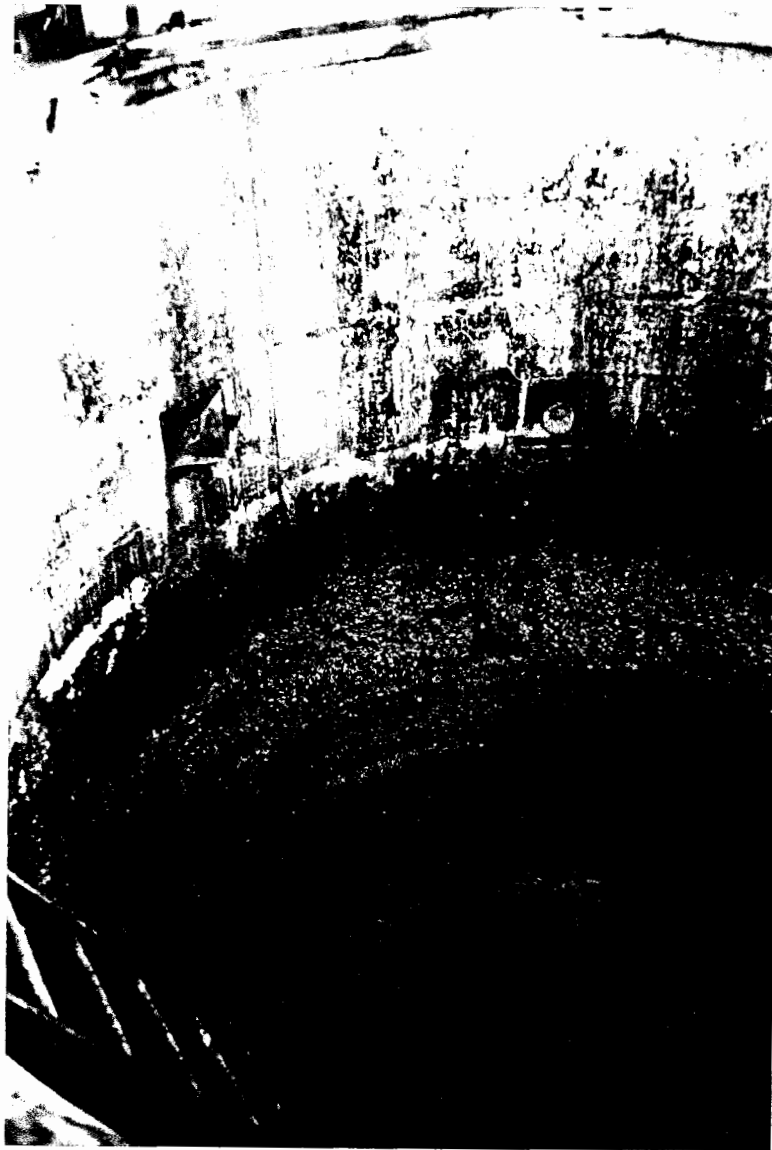
PHOTO No.: 10 of Roll 2

DESCRIPTION: Secondary containment to be decontaminated during closure of nitric acid tank. Final closure certification has not been submitted to the Office of Waste Management.

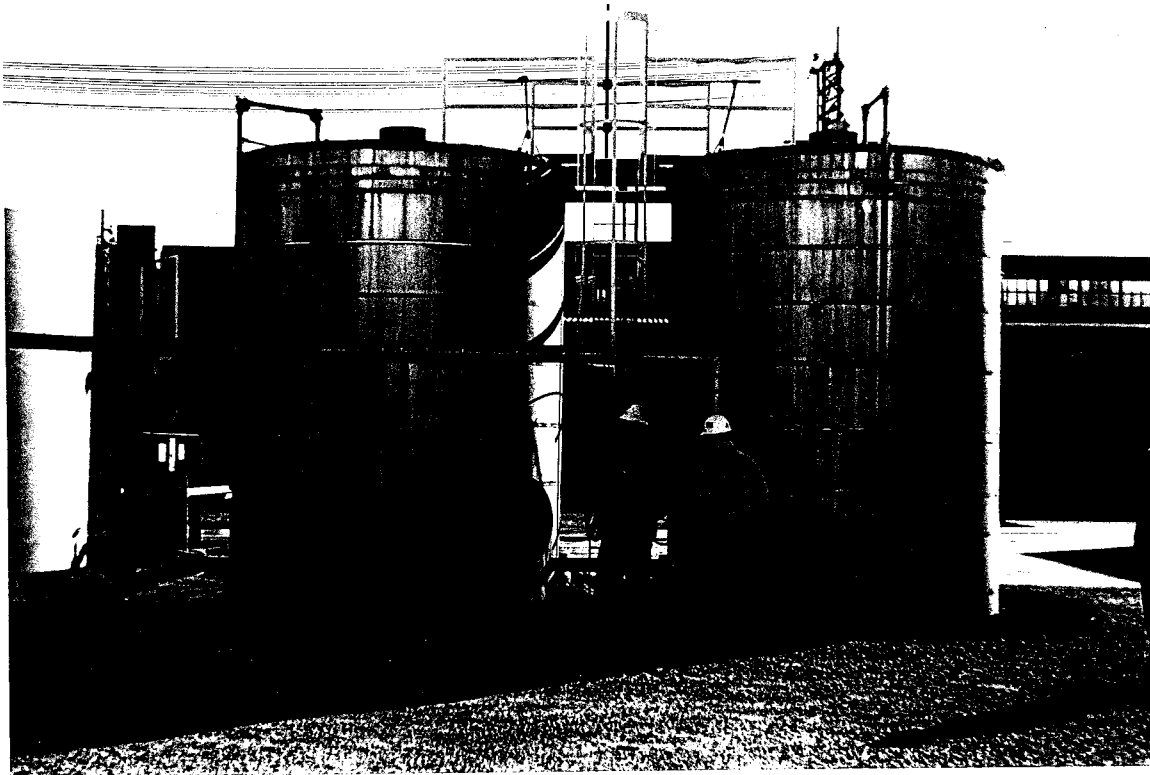
PHOTO No.: 12 of Roll 2

DESCRIPTION: Sludge holding tanks in the acid reclaim area. Sludge goes to monel tank for storage prior to treatment in neutralization tank.

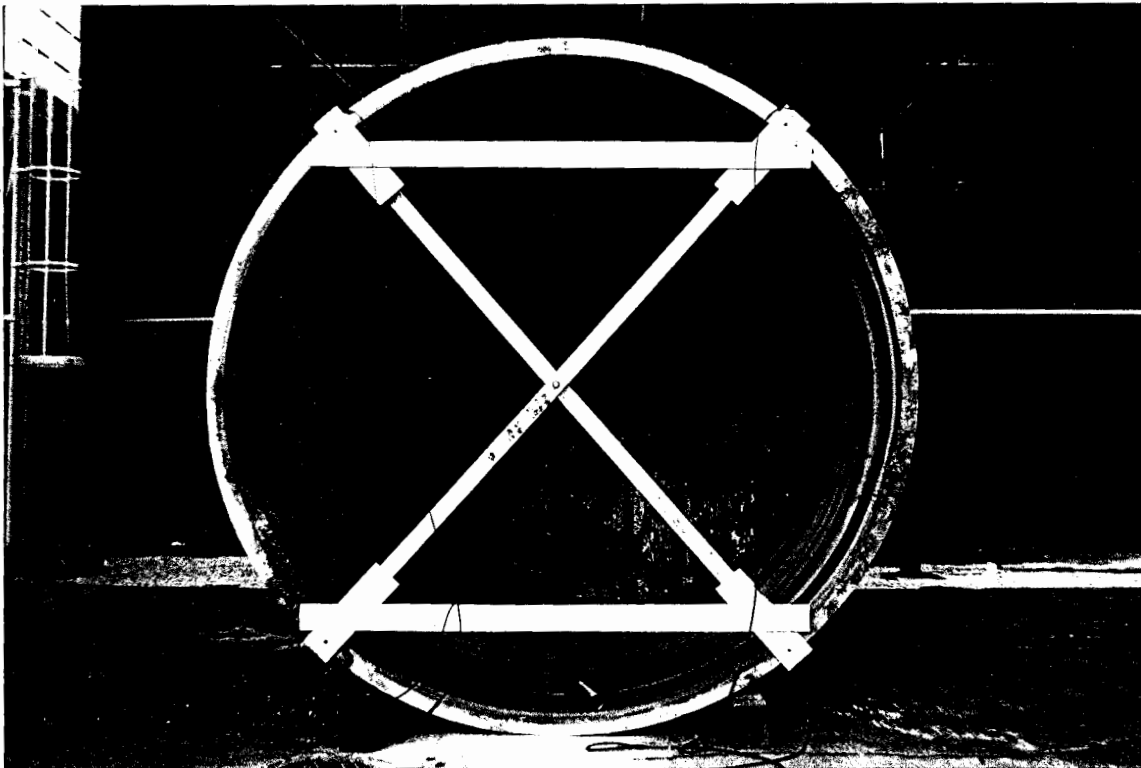
PHOTO No.: 1 of Roll 1

DESCRIPTION: Pictured is an 8,000 gallon holding tank that received hazardous waste from off-site, KY Plant, Nitric-HF tank. Tank was removed and prepared for shipment to off-site for disposal at the time of the VSI, January 20, 1992.

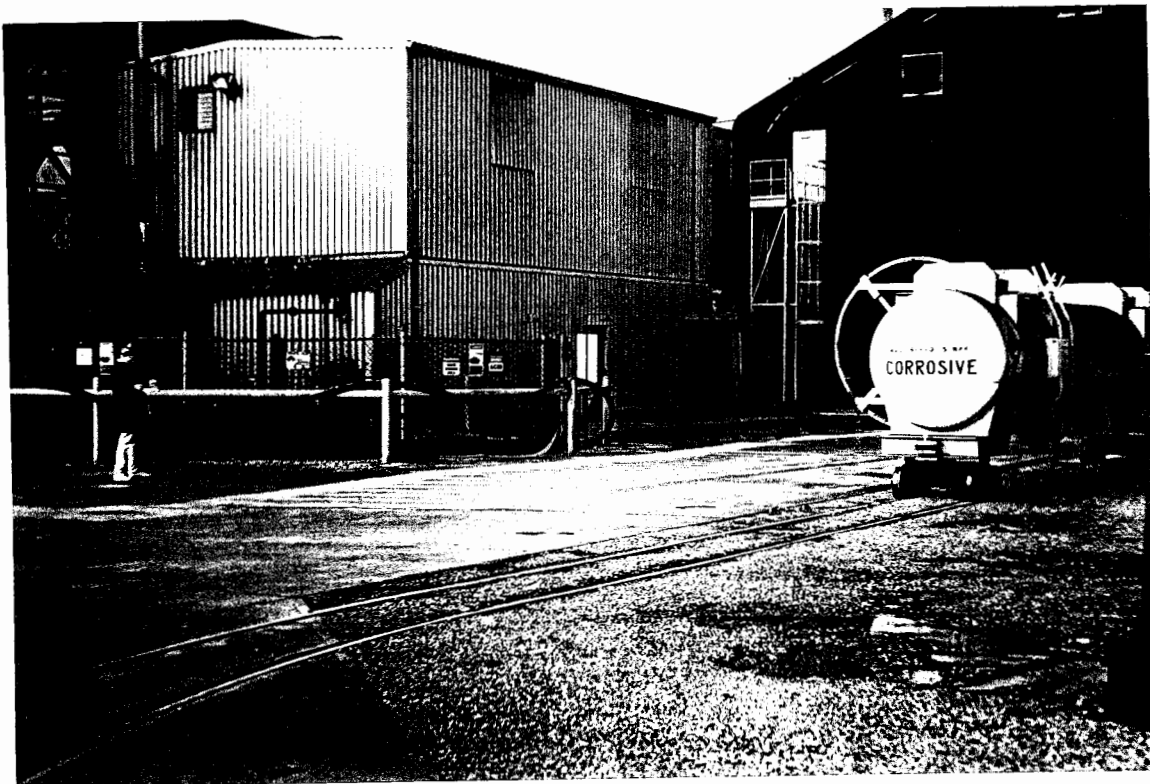
PHOTO No.: 3 of Roll 1

DESCRIPTION: The rail tank brings waste to the storage area, then waste is gravity feed to storage tank (monel tank).

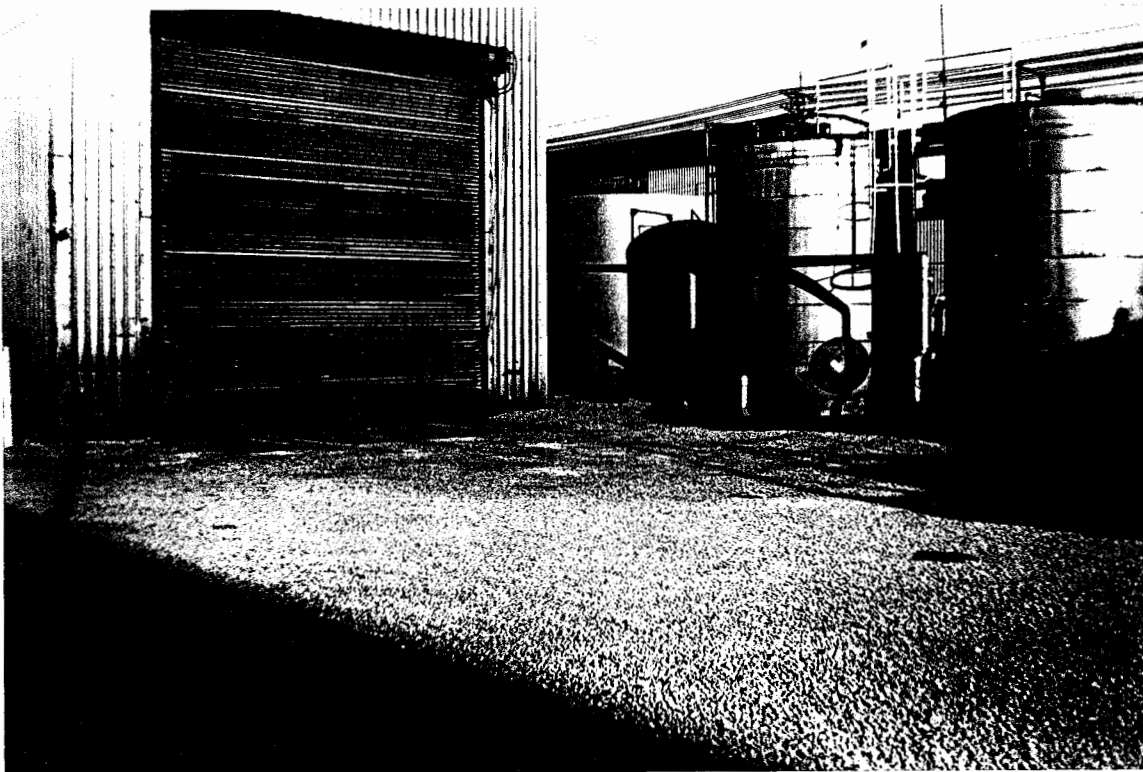
PHOTO No.: 6 of Roll 1

DESCRIPTION: Acid Reclaim Pre-treatment area - metals are actually reclaimed here. Multihearth roasting furnace - exit door is shown. Hazardous waste sludge (hex. chrome) was spilled outside of furnace building. The gravel area was the site of contamination. Remedial investigation was performed.

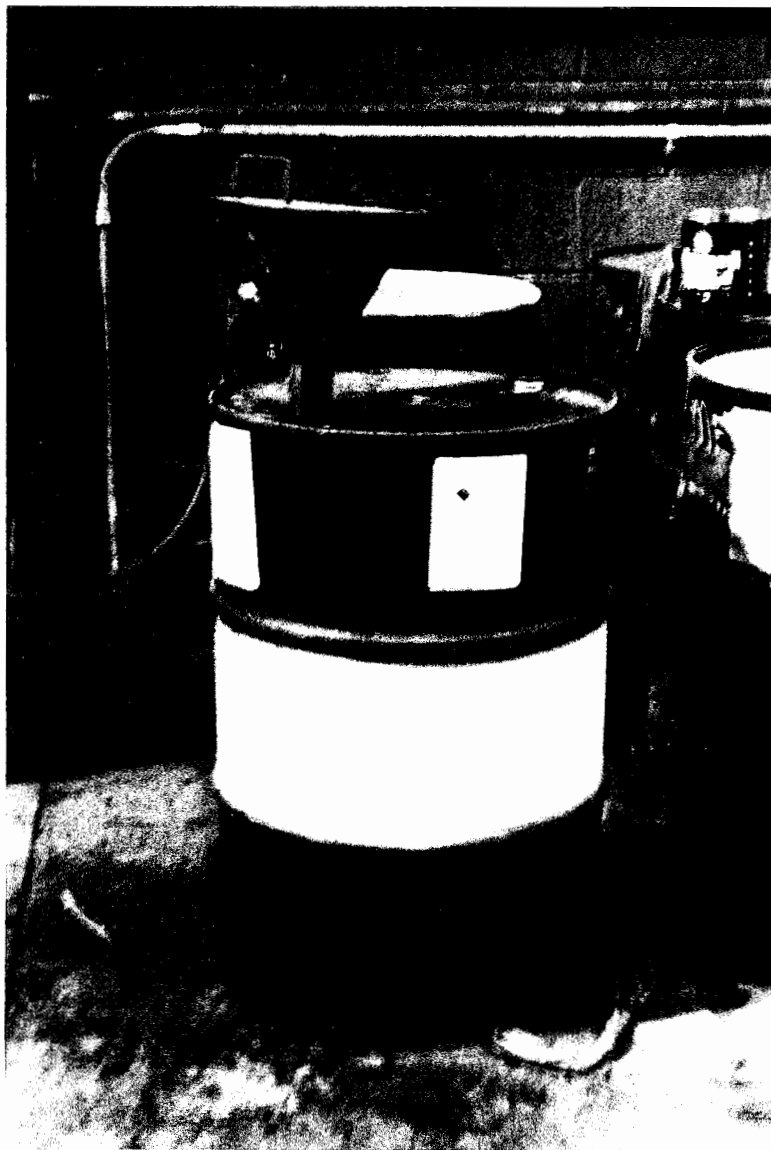
PHOTO No.: 8 of Roll 1

DESCRIPTION: Cold Draw Building - Dye Check Area. Rods, burs and tubing are tested here. Generates 1, 1, 1 tri-chloroethene, about 3-4 drums/yr. Satellite Accumulation Area.

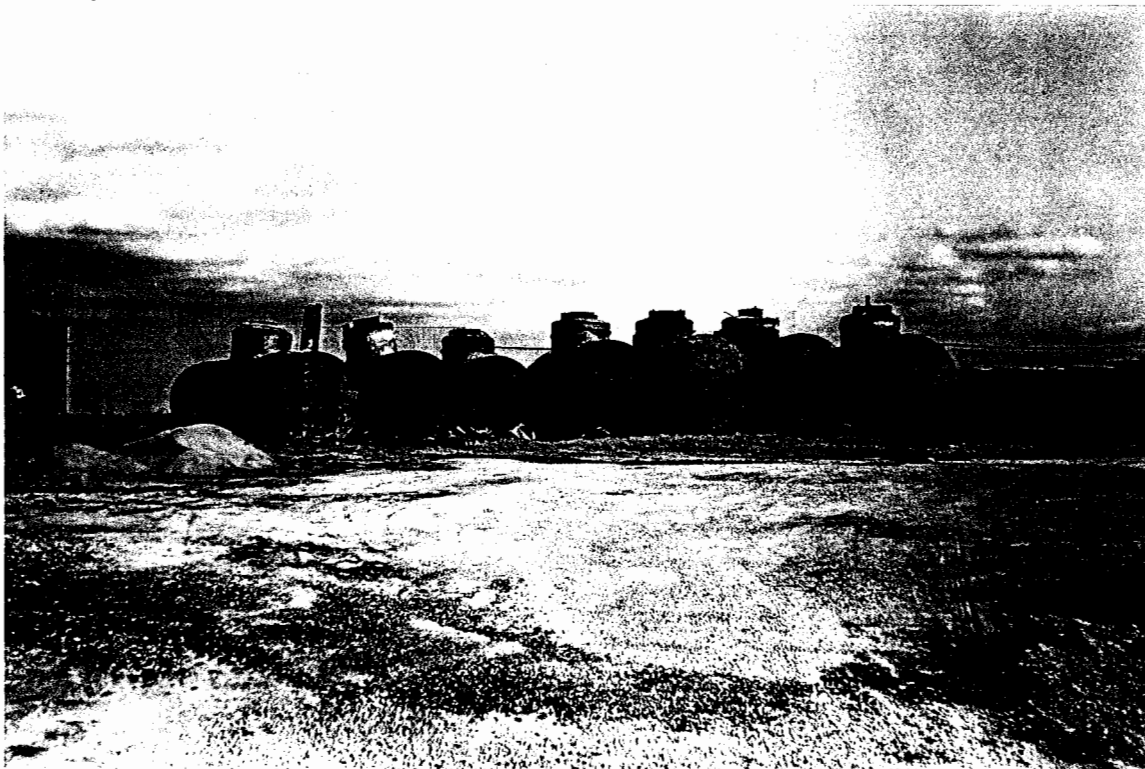
PHOTO No.: 10 of Roll 1

DESCRIPTION: Excavated seven (7) previously used Underground Storage Tanks. Hydraulic oil was stored in these tanks which were removed from service at the facility..

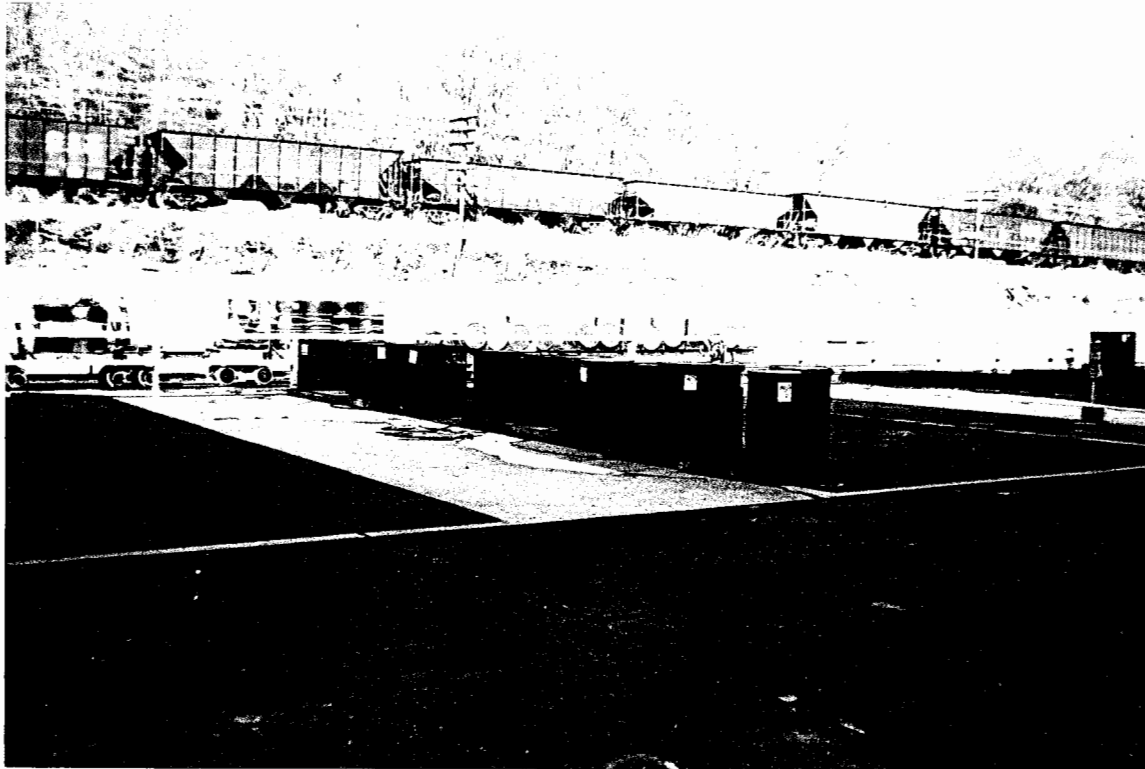
LOCATION: Hazardous Waste Drum Storage Area PHOTO No.: 12 of Roll 1
(Cell No. 3)

DESCRIPTION: This is a non-liquid drum storage area. Twenty (20) drums were stored in storage area at the time of the VSI, Jan. 20, 1992.
